**Causes of Early Cracking in Concrete Bridge Decks**

**MAP Brief November 2016**

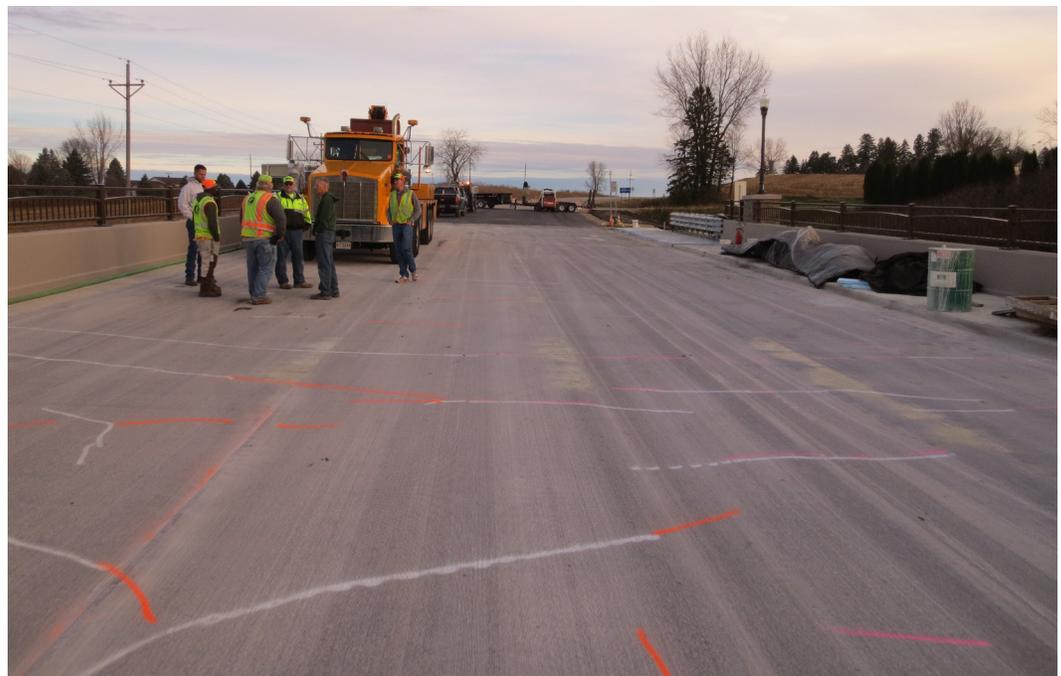
**Figure 1. Cracking (marked on deck surface) occurred before this newly constructed bridge was opened to traffic.**

The problem of deck cracking has existed in bridges for many years. The cracks commonly occur after construction but before the bridge is opened to traffic (i.e., days following concrete placement). Figure 1 is an example of such a bridge. In this particular case, the evidence of cracking on both the top and bottom of the deck (commonly observed only on the bottom initially) indicates that this bridge is particularly susceptible to moisture and chloride ingress—the cracks provide a direct pathway for the intrusion of water and chlorides. In the worst case, these early-age cracks could lead to a reduced bridge-deck service life. Interestingly, there have been instances where cracking has occurred in only one of twin, side-by-side bridges. This situation is confusing—the two structures should be the same, yet only one experiences cracking.

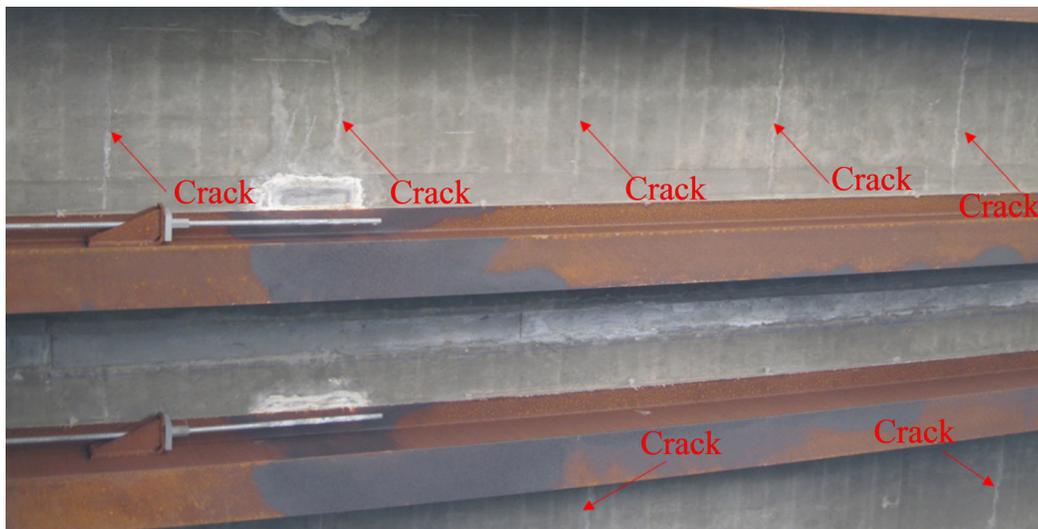
Figure 3. Bottom of deck cracking

With the above factors in mind and with the goal of understanding the degree and characteristics causing deck cracking, a study was initiated by the authors, during which 22 bridges constructed in the past five years were inspected and the deck cracks of those bridges mapped and analyzed. A typical crack distribution in a bridge with cracks and leaching is shown in Figures 2 and 3. Commonly observed crack characteristics can be best summarized as follows:

- Cracks are mostly perpendicular to the girders irrespective of the bridge skew. However, diagonal cracks are also sometimes present but tend to be restricted to the bridge ends.
- Cracks exist in both steel girder bridges and prestressed concrete girder bridges.
- Cracks are most commonly found near the pier location.
- Cracks are commonly spaced at 3-8 ft.
- Crack leaching indicates the cracks are full depth.
